HYDROGEN EMBRITTLEMENT IN WELDED REBAR

SEPTEMBER 2016 SUPPLEMENT

Hydrogen Embrittlement in Welded Rebar

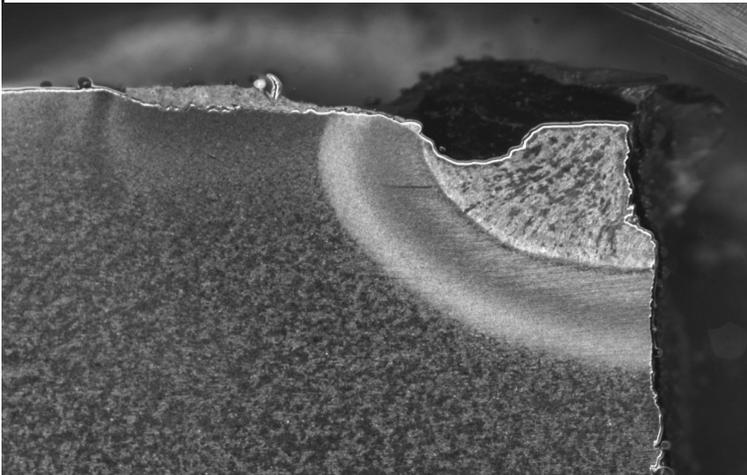
This photograph of a metallographic cross section of this fracture shows the fracture initiated in the heat affected zone adjacent to the weld. The hardness in the heat affected zone is HV (1000g) 571, or approximately HRC 53.6. This HAZ is harder than the lab fractures summarized above. The microstructure of the heat affected zone is fully martensitic. Note also the longitudinal cracking in the heat affected zone.

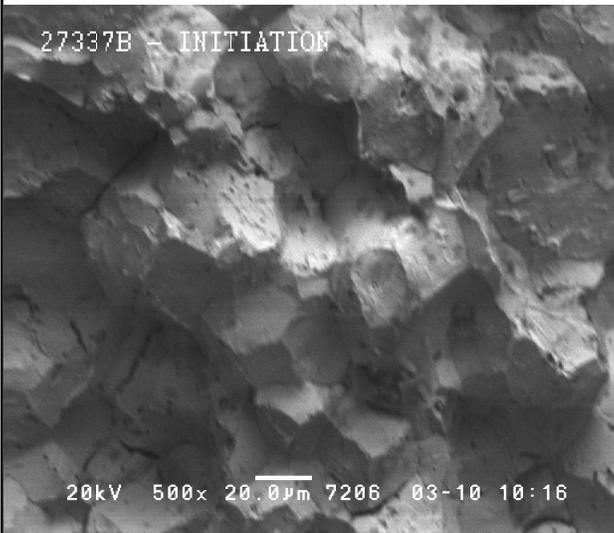
Scanning electron microscopy was also used on one of the fracture surfaces. The fracture initiation zone shows brittle intergranular fracture. The final fracture is primarily transgranular cleavage. The intergranular fracture in the fracture initiation area and the transgranular fracture in what should be ductile base metal are characteristic of hydrogen embrittlement.

SEM Image of Fracture Initiation. Note the intergranular fracture due to hydrogen embrittlement.

It has been determined that the root cause of the fractures was to be hydrogen embrittlement from the welding. Note 1 of ASTM A615 states:

The rebar samples have a carbon equivalent of approximately 0.66. Steels with a carbon equivalent of greater than 0.475 require preheating before welding to prevent hydrogen induced cracking. The preheating reduces the cooling rate of the heat affected zone and provides a more ductile microstructure that is less susceptible to hydrogen cracking. The slower cooling also allows more time for hydrogen to diffuse out of the weld. The combination of high carbon content and relatively high hardenability of the rebar samples suggests that in addition to preheating post weld heating would also be appropriate.
