FAILURE IN THE FOOD INDUSTRY

Food Industry Stainless Steel Corrosion Case Study

NHML was inquired about a problem that a customer was having with their heated food well pans. The pans that were in question are built into a heated food warmer where they would be filled with water then heated to warm containers of food. They provided us with 2 stainless steel well pans to evaluate for a failure analysis. One of the pans provided had failed with signs of corrosion and the other was new and in good condition to be used for comparison. The failed pan was leaking water at the area of corrosion and our job was to find out why it had failed in the first place.

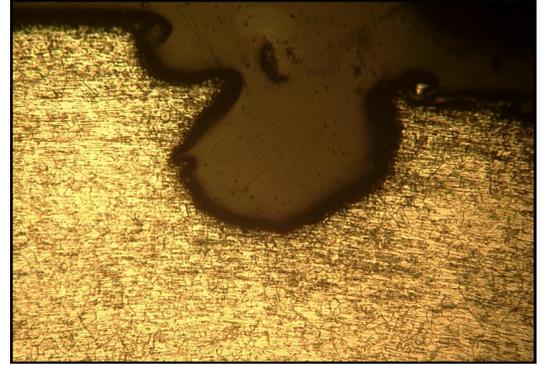
As seen in Figure 1, through examination we found there was only pitting corrosion. There was no evidence of stress corrosion cracking, general corrosion or galvanic attack. No crevice corrosion was found either; however, crevice corrosion is related to pitting attack as noted below in the Discussion section. Figure 2 was the elemental analysis showing that the contents of the pit were principally carbonaceous food debris. There was a trace amount of chlorine that was found as well. The sensitivity of the EDS analytical technique suggested that the amount of chlorine in the pit was of the order of 0.1%, which is more than enough to sustain the pitting reaction.

Figure 1: Metallographic section through the center of a pit

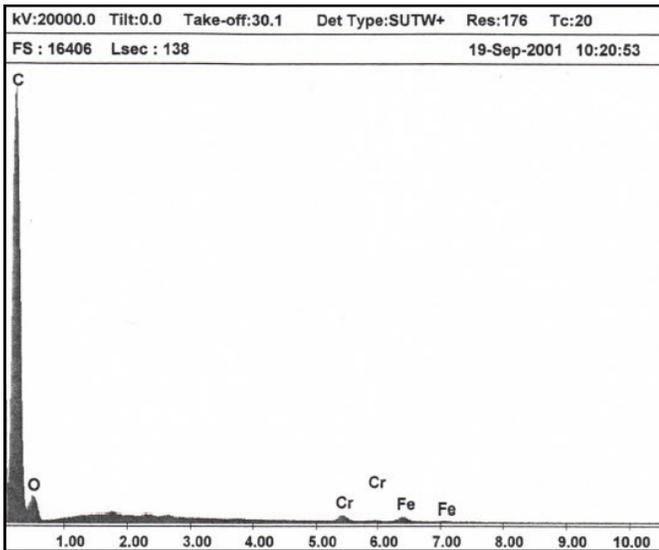
Figure 2: Elemental analysis results using the EDS accessory of the SEM within the pit in figure 1. The trace element emissions are unlabeled on the spectrum. Major-Carbon, Minor-Oxygen Chromium and Iron, Trace-Silicon, Sulfur and Chlorine

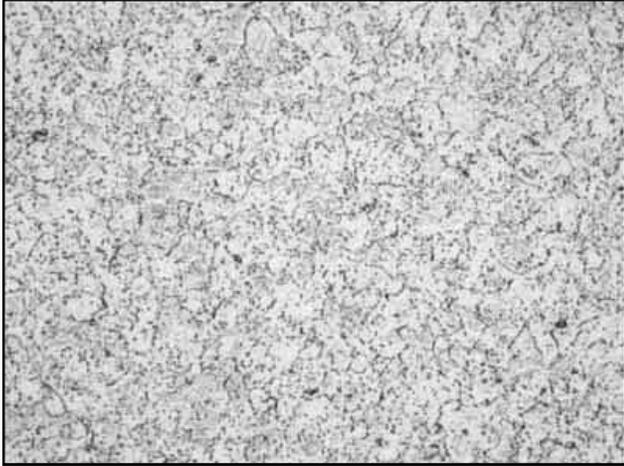
Figure 3 shows the microstructure of metal adjacent to a pit. The metallographic sample taken from the rim of the intact pan showed microstructure that is indistinguishable from figure 3. The following information was derived from figures 3 and 4:

The metal was slightly cold worked, which is consistent with the samples' locations in lightly deformed areas in the pan's bottom and rim.

The metal was briefly annealed after it was rolled into sheet form. It was not annealed after being formed into the actual pan.

Figure 3: Microstructure of the metal adjacent to a pit. Area is on the pan's flat bottom, slightly deformed during cold forming. 400x

Alloy 304 often demands no premium price over 302. We suggested that they specify 304 rather than 302 to take advantage of 304's higher chromium and nickel content along with a lower carbon.

Specifying a sensitization acceptance test may price the product out of competitive range. We suggested they explore the available options with their metal supplier.

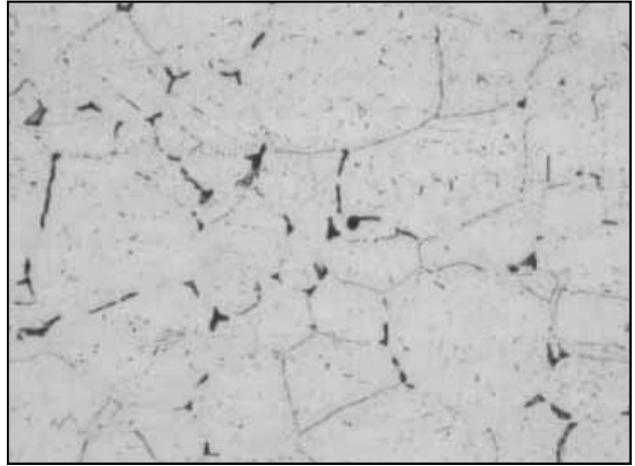
A minor phase was allowed to precipitate in the grain boundaries. We believed that the minor phase contained carbides. Their presence indicates the metal was in a sensitized condition making it more susceptible to pitting. The cause of the precipitation was too slow cooling from the annealing temperature.

Figure 4: SEM photo of minor phase particles in the austenite grain boundaries.
