New Hampshire
MATERIALS
LABORATORY, INC.
Your Problem Solving Partner

O-RING FAILURES

SEPTEMBER 2013 ISSUE #10

O-Ring Failures

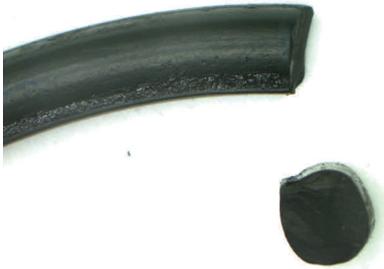
Example of extrusion and wear

The remaining (mechanical) O-ring failures are usually design related. These failures include wear, extrusion, blow-by due to excessive pressure and explosive decompression. Abrasive wear is usually seen as a flat surface over all of a portion of the O-ring surface. This is the result of a rough finish on the sealing surfaces or abrasive particles in the system fluid. A flat surface on the O-ring may also be due to compression set, usually due to excessive compression caused by poor gland design, but sometimes caused by the selection of an elastomer

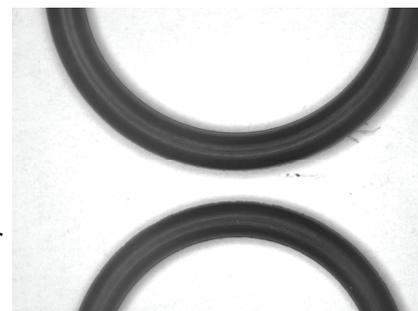
Example of swelling (top) due to chemical attack

Chemical degradation may result in blistering, softening or cracking. The deterioration in mechanical properties by chemical degradation may also not be evident in a visual examination, but only revealed by mechanical testing. While a flat surface on an O-ring may be the result of compression set during assembly, excessive swelling due to chemical exposure is often the reason for a flat surface.

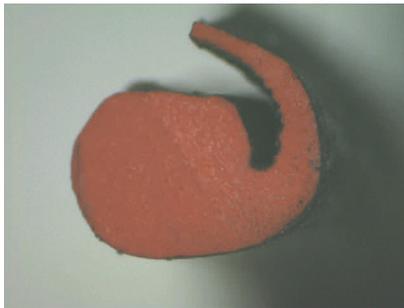
Example of Gross Extrusion Cross Section

Extrusion results in ragged edges on the low pressure side of the O-ring. This can be caused by excessive pressure or excessive clearances, but we see this phenomenon most commonly associated with a softening or swelling of the elastomer due to exposure to an incompatible chemical. An internet search for "elastomer compatibility" will generate a number of useful guides for compatibility.
