HYDROGEN EMBRITTLEMENT IN WELDED REBAR

SEPTEMBER 2016 SUPPLEMENT

Hydrogen Embrittlement in Welded Rebar

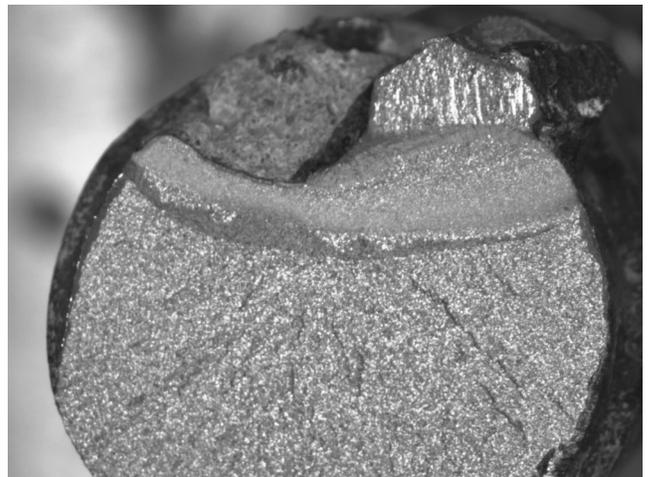
Chemical analyses of the rebar samples, and of an accident fracture, were performed using glow discharge spectroscopy. A chemical analysis of one fractured anchor bolt (B1) was also performed. These results are summarized on the below table.
