NUTS & BOLTS

NH Materials Laboratory, Somersworth, NH ■ 800-334-5432 ■ www.nhml.com

Hydrolysis of Fiberglass

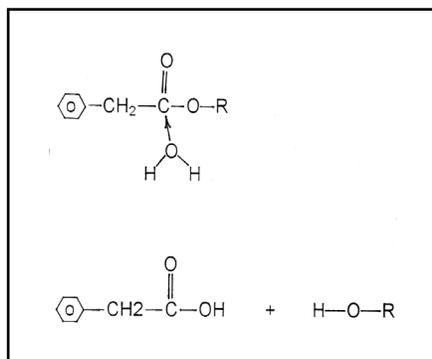
An ester molecule has the following structure:

The hexagon is a ring-type group such as a benzene. In polyester, R is a carbon and hydrogen chain-type group. In vinyl ester, R is a vinyl chain. When these esters undergo hydrolysis, a water molecule attacks the bond between the central carbon atom and the adjacent single-bonded oxygen atom. The water molecule dissociates into a hydrogen atom and an OH pair. The OH pair takes the

place of the original single-bonded oxygen while the hydrogen joins the O-R to become H-O-R. The C = O pair is referred to as a carbonyl.
