NUTS & BOLTS

NH Materials Laboratory, Somersworth, NH • 800-334-5432 • www.nhml.com

GLASS VIAL SPRINKLER ACCIDENTS

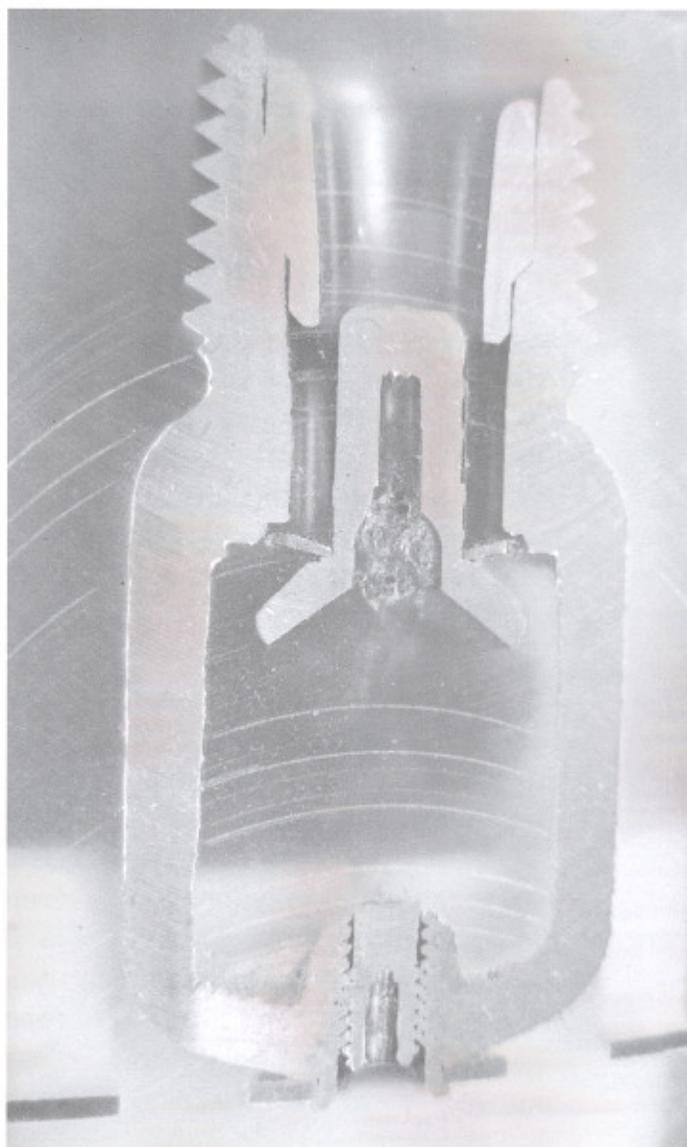
Typical sprinkler head of the glass vial type. Pressure from corrosion on the ends can break the vial.

In this family of sprinklers the glass vial is captured between the adjusting screw on its outboard end and a plug or insert that fits into the body. The water seal is created around

either a slightly cupped stainless steel washer or between the plug and the body. With the washer, the ID of the washer is tightly fitted around the plug. The washer's OD rests in a shallow counterbore in the body.

4 Corrosion on either the face of the adjusting screw or on the face of the cup that increases the axial force on the vial until it bursts.

5 For those sprinkler heads in which there are seals around a stainless steel washer, we have seen an accumulation of expanding corrosion product between the stainless steel washer and either the plug or the sprinkler body counterbore that increases the axial force on the vial until it bursts.
